# Death in the line of duty...

A Summary of a NIOSH fire fighter fatality investigation

May 13, 2003

# Volunteer Fire Fighter Dies After Being Run Over by Brush Truck During Grass Fire Attack - Texas

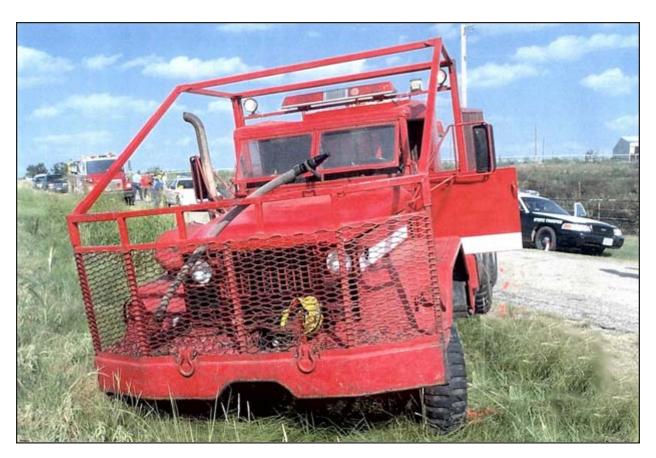
Photo 1. Front view of the front-bumper mounted platform

The working platform was built by the fire department onto the front bumper of the brush truck and extended out approximately 36 inches. The platform had an open frame that extended up to the cab and then down the sides of the bumper. The lower front portion

of the frame was mesh wire, which extended 39 inches from the top of the bumper to the cross member. The rest of the frame was open allowing uninhibited access from either side (Photo 1).

Discussion: In this case, the victim was holding a charged hoseline and attacking the fire from the frontbumper-mounted working platform on the brush truck. There was a 39-inch metal guardrail opensided at both ends. The platform was mounted on the front bumper, which is where the victim was working while the brush truck was moving. According to the International Fire Service Training Association (IFSTA), there are two proper methods for making a moving fire attack: "The first method is to have fire fighters use a short section of hose and walk alongside the apparatus and extinguish the fire as they go." The NFPA 1500 Standard for the Fire Department Occupational Safety and Health Program concurs with this recommendation. Further, this standard strongly recommends that "two fire fighters, each with a hoseline, walk ahead and beside of the vehicle's path, both fire fighters on the same side of the uninvolved terrain. This allows the fire *vehicle*. <sup>1,2,5</sup>

Recommendation #1: Fire departments should ensure that fire fighters attack a brush fire from a safe place on the apparatus or walk alongside the moving apparatus.<sup>1,2,3,4</sup>

The second IFSTA recommendation is to use nozzles that are remotely controlled from the inside of the cab. The practice of fire fighters riding on the outside of vehicles and fighting wildland fires from unprotected positions is not recommended by NFPA Standards.

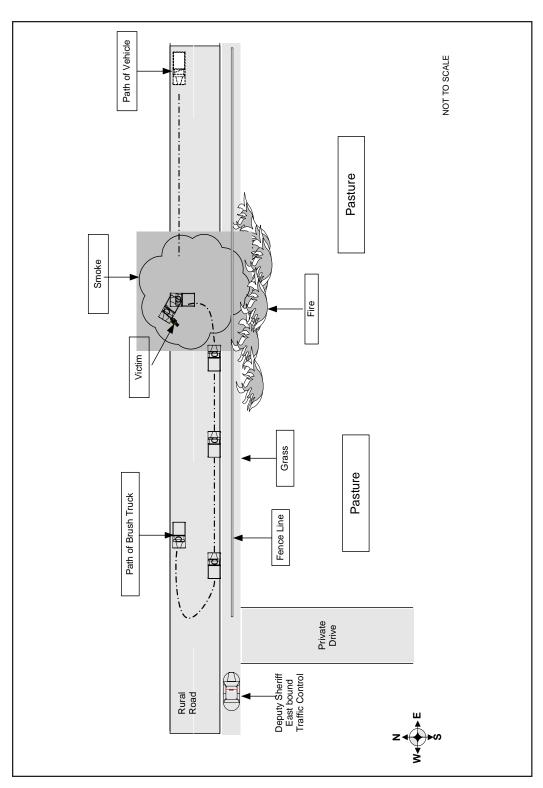
Diagram. Aerial view of brush truck incident scene

The Assistant Fire Chief was first on the scene at 1626 hours and assumed incident command (IC). The IC called for traffic control and sized up the area of fire origin on the residential property. The fire was noted to have started in a pasture near a manure pile between the State road and the rural road (Diagram). The fire was spread approximately 300 feet long and was burning near the fence line, threatening to cross the rural road.

Crews with the two engines were attacking the fire from the State road on the south side where smoke had become thick and was blowing across the roadway, diminishing visibility. The deputy sheriff arrived on the scene for traffic control at the west end of the rural road (Diagram). Traffic control for the east end was en route at the time of the incident. The brush truck made a pass at the fire with a charged hose line from west to east and then turned north, making a U-turn across the roadway, presumably to make another pass to extinguish the fire near the fence line. A witness stated that he saw the driver of the brush truck reach the end of the fire line and make a U-turn across the roadway where the truck came almost to a halt. A pickup truck traveling in the westbound lane at approximately 30-40 miles per

hour (according to the traffic report) passed through the heavy smoke toward the brush truck, skidded 56 feet, and impacted the right front tire of the truck (Diagram). Note: According to the state fire marshal's report, the driver of the brush truck was not wearing a seat belt, and upon impact, was thrown across the interior, losing control of the vehicle. The impact caused the victim to be ejected from the work platform to the ground directly in front of the rotating front left tire of the brush truck.

Recommendation #2: Fire departments should ensure that adequate traffic control is in place before turning their attention to the emergency.<sup>4,6,7</sup>

Discussion: The Incident Commander sized up the grass fire area and called for traffic control for both the east and west entrances to the rural road. The deputy sheriff was blocking the west entrance, and traffic control was en route to the east entrance when the incident occurred. According to Dunn, "When a fire company arrives on the scene of a roadway emergency and there are no police at hand to control traffic, fire fighters themselves should first control the oncoming vehicles before safely turning their attention to the emergency. It is recommended that warning signal devices such as flares, flags, road blocks, or road signs be placed at a minimum of 350 feet from the incident scene (further distance may be required taking into account line of sight, visibility, road and weather conditions) and positioned so they are visible to oncoming traffic for at least 350 feet beyond that. This placement allows the driver a minimum of 700 feet in which to stop a vehicle.
